# HISTORIC RESOURCES INVENTORY BUILDING AND STRUCTURES

T. Maitland Cleland House

Danbury

Long Ridge Road

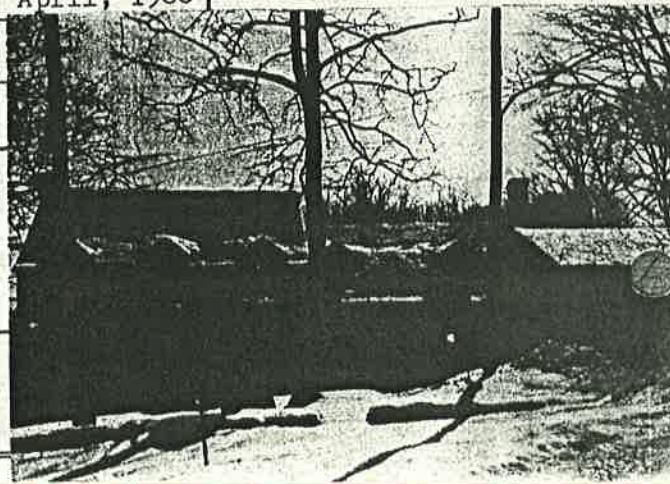
north facade

The house is rectangular in shape, with a two-bay breezeway which leads to an attached garage. The one-and-one-half story Cape form with its steeply pitched roof pierced by three gabled dormers is repeated in the breezeway section, on a smaller scale. The off-center entry is sheltered by a portico with closed pediment. Windows throughout are six over six.
