APPRAISAL REPORT

Owner Parks-Mercier Incorporated
Owners' Address 70-84 Beaver Street, Danbury, Connecticut
Property Appraised 3.092 acres of land together with 7 buildings as shown on Plot plan. Known as Parcel 28 Block 4 on Redevelopment map. Also known as Tax Parcel 51 W/S Main Street.

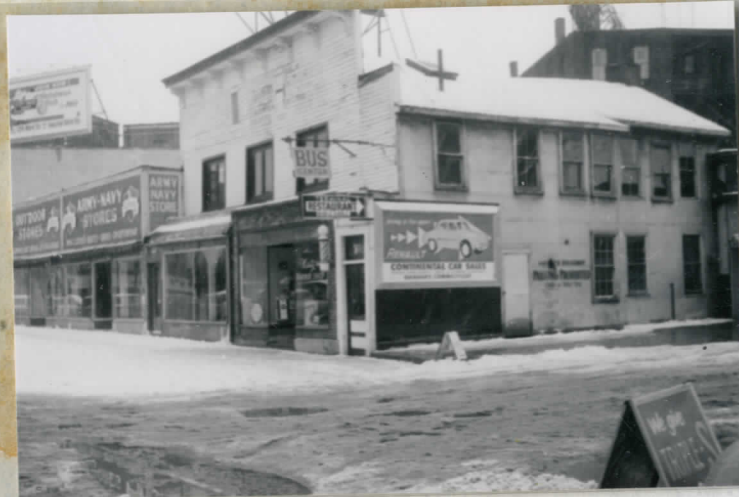
Building #1.

Building #1 (3,888 sq. ft. Ground Floor 2,438 second floor).

This is an old store building in very poor condition. There is a basement under the 2 story portion only, and it is very poor with a dirt floor.

Floors are of concrete with asphalt tile cover (linoleum in Barber Shop). Walls and ceilings are plastered with metal squares for ceiling cover. Exterior walls are clapboard with metal sheathing on one side. Roof is composition type.

In the larger store there are two, three fixture lavatories. There is an additional toilet room in the barber shop. Central heat is not in working order. (Stores have individual heating). Building is in poor condition.

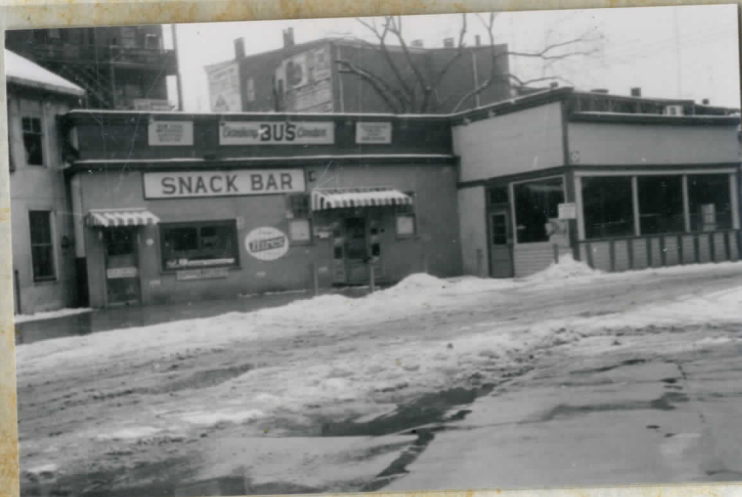
Building #2.

Building #2 (3,400 sq. ft.-one floor, no basement).

This is a snack bar and bus waiting room and a lounge-bar. It is in fair condition. It has cement floor wallboard interior, wood post supports. Some of the walls are in "walltex", a simulated wood panelling. Floors in the depot section are asphalt tile covered. Bar room has linoleum floor and waincot. There is a 4 fixture men's room and a 3 fixture ladies' room in this building. Heat is by 2 overhead blowers.

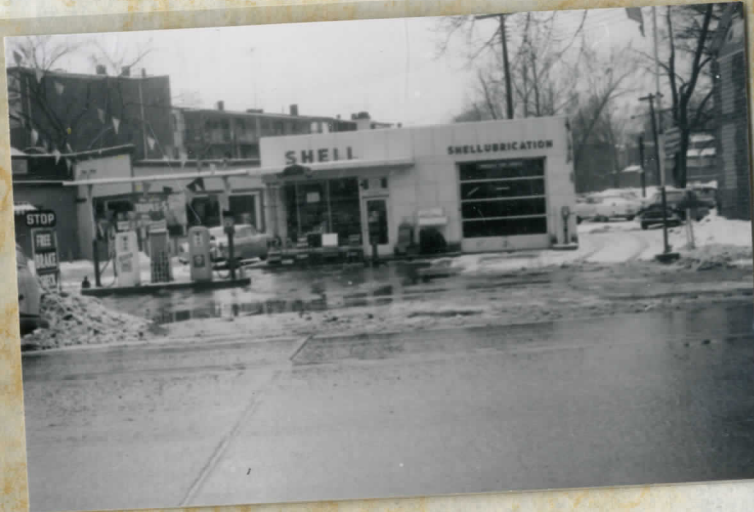
Building #3.

(Service station - Bldg. #3 and Garage Bldg. #5.)

Occupancy Service Station Building Class C
 Quality Good Age Remodelled Condition Good
 Number of Rooms - Number of Baths 56 Number of Lav. 2 tiled
 Number of Stories 1 Total Height - Average Story Height -
 Single Floor Area Approx. 900 sq. ft. Total Area -
 Shape: Approximate Square X Rectangle or Slightly Irregular - Long Rectangle or Irregular -
Very Irregular
 Total Unit Cost Per Square Foot (From Page 3) \$15.00
 Correct for Size and Shape -
 Height -
 Dist. Multiplier -
 Total Adjusted Cost Per Square Foot -
 Total Area 900 X \$15.00 Per Square Foot -
 Replacement Cost \$13,500
 Less Depreciation 1,350
 Physical 10% Functional - Economic -
 Building Value By Cost Approach Service Station Bldg. #3 \$12,150
 Value of other Building Improvements Garage-Bldg. #5 4,950

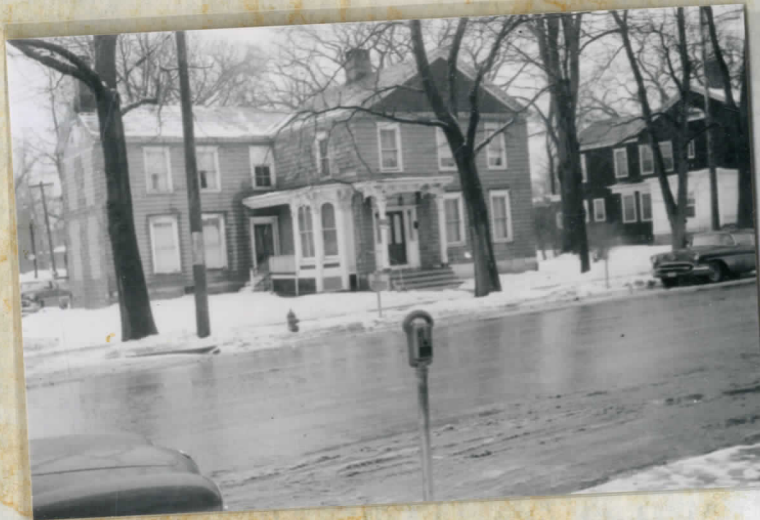
Building #4.

Building #4 (2048 sq. ft.-first floor, 1,730 sq. ft. second floor, and 1730 sq. ft. basement).

This is a rooming house approximately 95 year old. It has a stone foundation, old hand hewn post and beam supports. Part of the floor is cement, part dirt. Exterior walls are wood shingle, interior plastered. Floors are Oak and Maple. Roof is tarpaper. Heating is by hot water-radiator with boiler, oil fired. There is a gas hot water heater, and a coal fired hot water heater. House is rented but as rooming house and has 12 rooms, 3 baths and a toilet room. House is generally in poor condition inside and out.

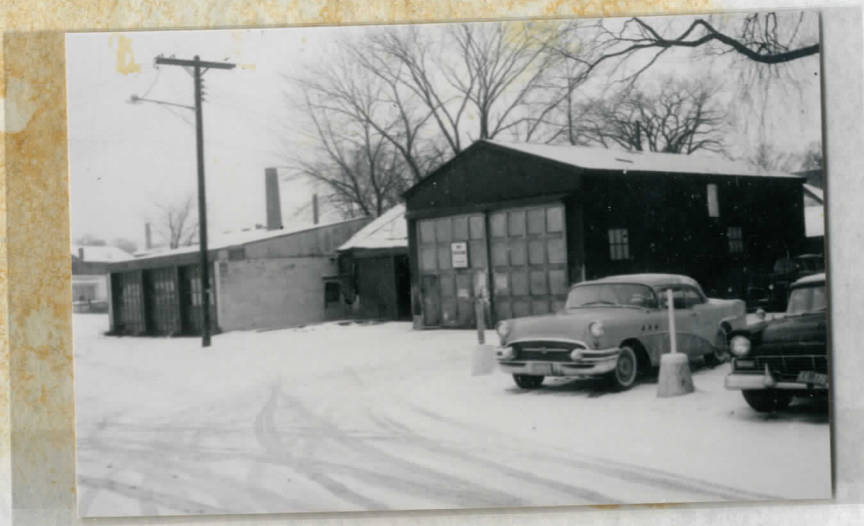
Building #5 and #6.

Building #6

This is a galvanized iron garage 24' x 40' in only fair condition. (960 sq. ft.)

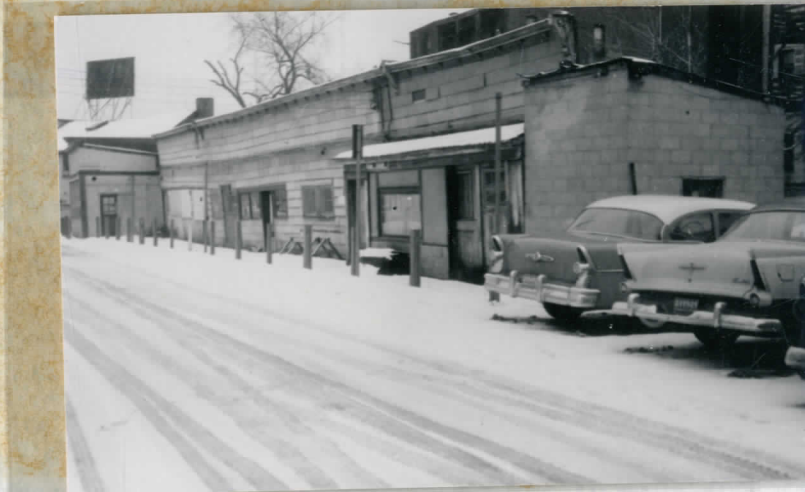
Building #7.

Building #7

This is a long narrow one story building in deplorable condition. 18' x 89' plus 4' x 23.5' plus 9' x 11' a total of approximately 1,800 sq. ft., no basement. Building is of little value.
